Final Report

CONDUCTING AN EVALUATION STUDY FOR REGULATORY COMPLIANCE AMONG RESORTS/HOMESTAYS IN AND AROUND TADOBA

February 2024

Conservator of Forests & Field Director,
Tadoba-Andhari Tiger Reserve

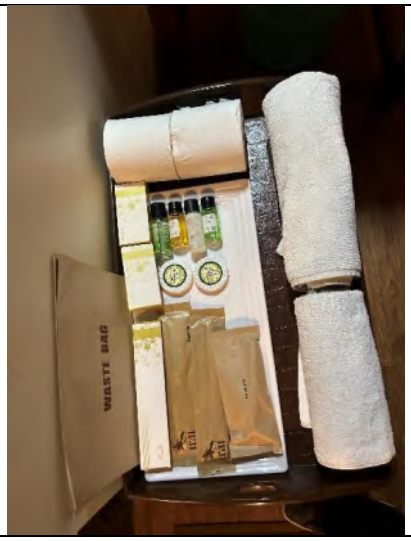
Irai Safari Retreat

6. Bamboo leaves burnt near laundry and other areas.
7. Discharge of untreated laundry water into bamboo plants.
8. No sub-meter for electricity and water.

12. Plastic waste found in premises along boundary wall at a few places (including compost pit)
13. One button switch is absent in cottages.
14. Plastic bottle toiletries.

18. Mechanism for waste water management is poor.
19. Absence of aerated water taps.
20. Absence of recycling, upcycling of non-biodegradable waste including plastics, paper.

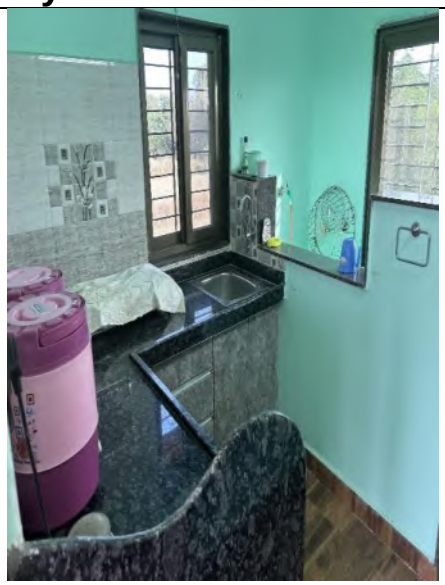
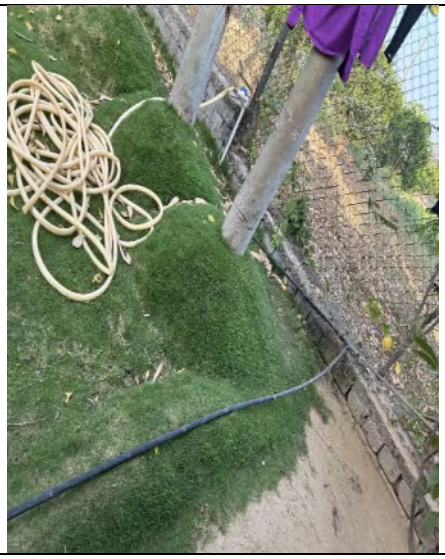
1. Absence of non-polluting DG set
2. Burning of plastics and other waste observed inside the premises
3. Absence of Layout Plan in Visitor rooms
4. Absence of one button system in rooms

8. Absence of waste quantification process
9. Absence of recycling, upcycling of non-biodegradable waste including plastics, paper
10. Lack of knowledge about SDGs, carbon footprint calculations and emissions.

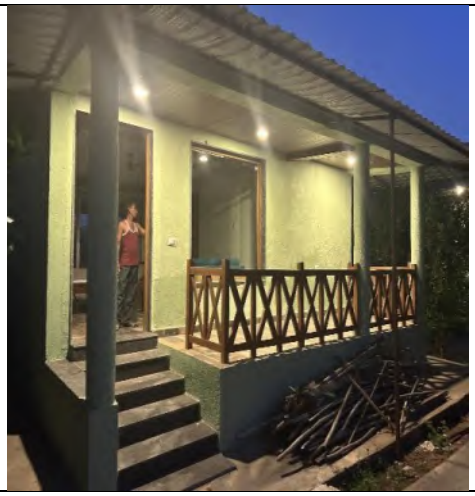
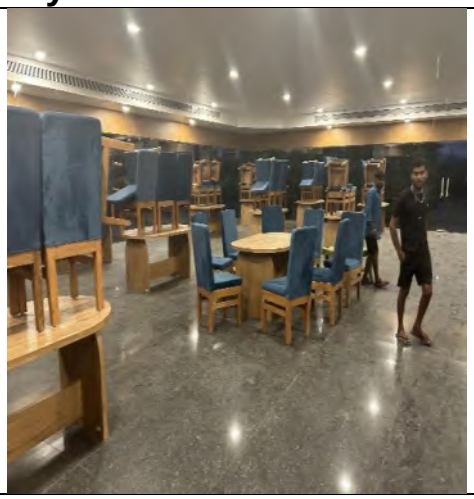
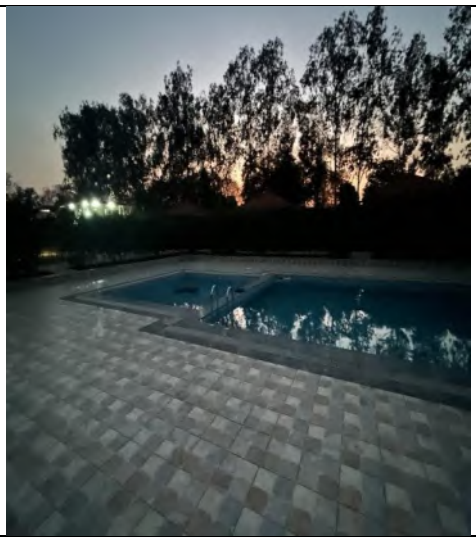
Hotel and Resort (Neel Resort)

4. Guests served water in Plastic bottles
5. Absence of waste quantification process
6. Absence of recycling, upcycling of non-biodegradable waste including plastics, paper

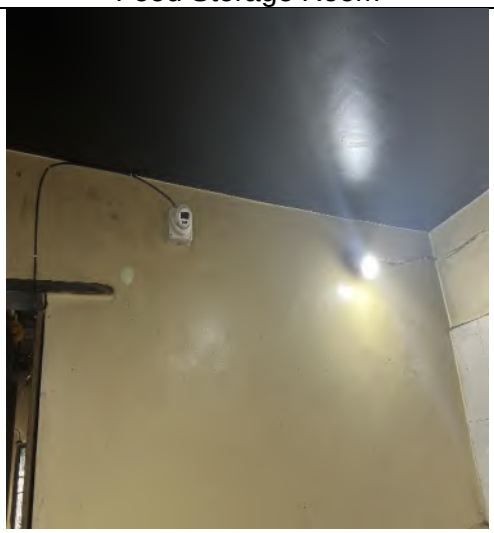
Rajputana Hotel

1. Single flush system in washroom with no toiletries in dispenser
2. Absence of Layout Plan
3. Plastics found inside the property premises.
4. Absence of STP and grease trap for wastewater treatment

8. Absence of recycling, upcycling of non-biodegradable waste including plastics, paper
9. Lack of knowledge about SDGs, carbon footprint calculations and emissions.

10. Absence of dustbins at adequate places
11. Mixed waste found in kitchen bin.
12. Absence of fire extinguishers at adequate places
13. No association with NGO for awareness campaigns or encouraging livelihood.

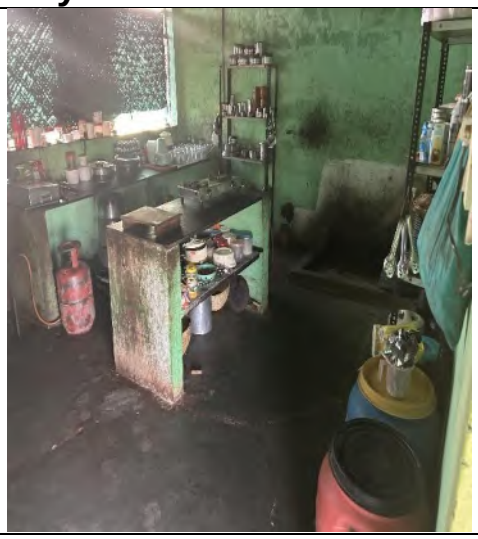
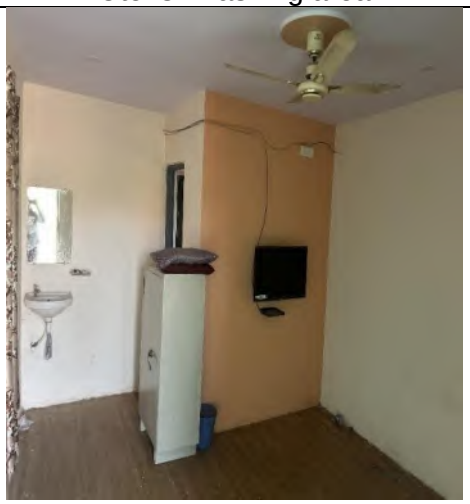
Tiger Home Stay (Lalsare Home Stay)

1. Absence of non-polluting DG set
2. Single flush system in washroom with no toiletries in dispenser
3. Absence of Layout Plan in Visitor rooms
4. Plastics found inside the property premises.

8. Absence of waste quantification process
9. Absence of recycling, upcycling of non-biodegradable waste including plastics, paper
10. Lack of knowledge about SDGs, carbon footprint calculations and emissions.

18. Damaged Well, required proper maintenance.
19. Absence of N.A certificate and falls under No Go Zone

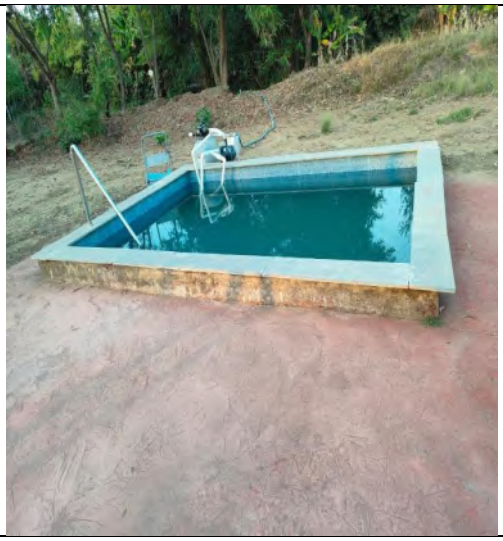
BODHIVAN JUNGLE CAMP

1. No segregation of waste observed.
2. Burning of leaves and other waste observed.
3. Usage of plastic drinking water bottle and toiletries in plastic bottle observed.
4. Polluting and noisy DG set (62.5 KVA).
5. Lack of training amongst staff members on environmental issues.
6. Sanitation in and around the property not upto the mark.
7. No STP or septic tanks. (only soak pits in operation).
8. No Awareness about SDGS, Carbon Footprints etc.
9. No concept of sanitary waste, C & D waste E-waste management.

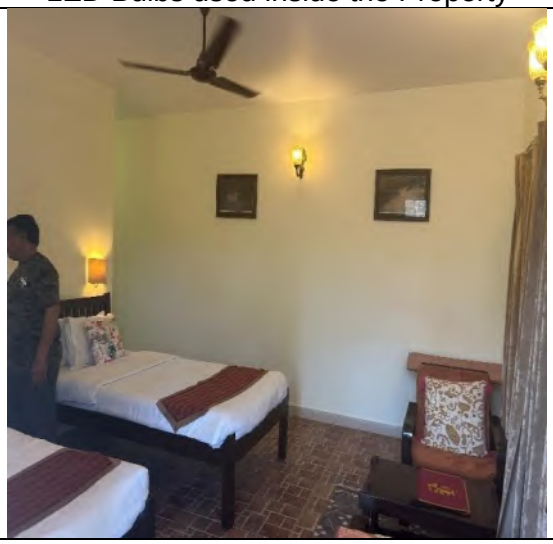
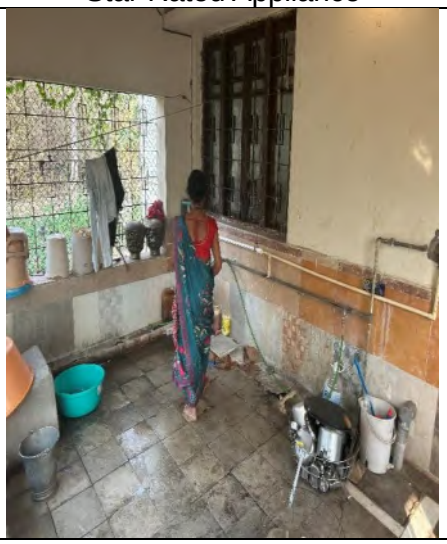
Tiger Trail Jungle Lodge

10. Absence of waste quantification process
11. No IEC material for visitors to highlight waste, water and energy management.
12. Absence of fire extinguishers at adequate places in the premises (Control panel, diesel store etc)
13. Absence of water meter
14. Plastics found in compost pit
15. Absence of Dustbins near toilet seat
16. Absence of adequate signages across the property
17. Absence of STP and grease trap for wastewater treatment
18. Kitchen waste is mixed with plastics
19. Absence of swimming pool rules and its depth near pool area
20. Single flush system in washroom with no toiletries in dispenser
21. Lack of knowledge about SDGs, carbon footprint calculations and emissions
22. Absence of recycling, upcycling of non-biodegradable waste including plastics, paper.
23. Absence of Souvenir Shop
24. Absence of Layout Plan in Visitor rooms

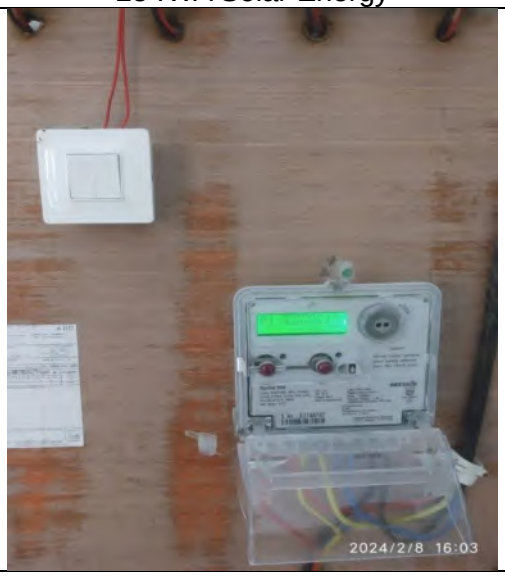
Open Septic tank

Swimming Pool

25 KVA Solar Energy

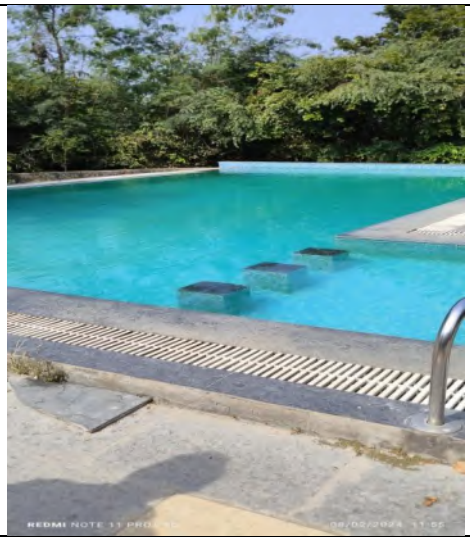
Water body inside lodge

Old D.G set

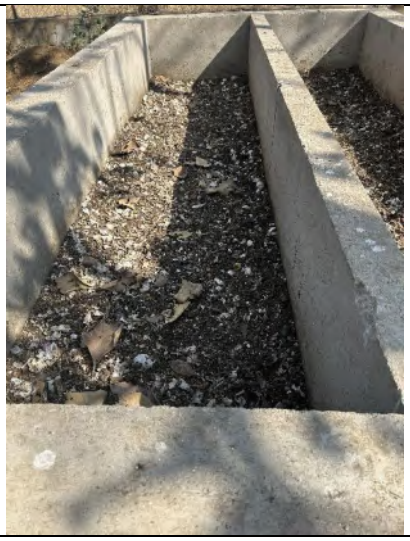
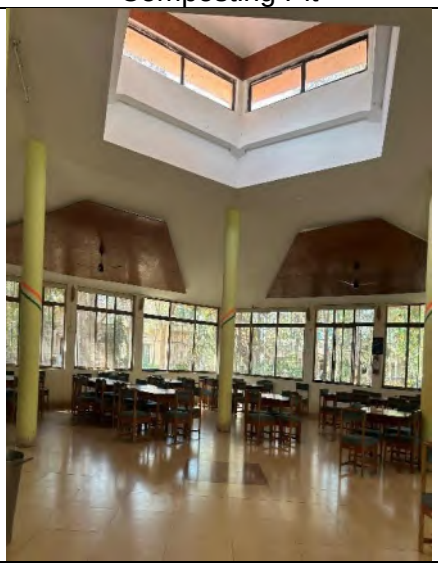
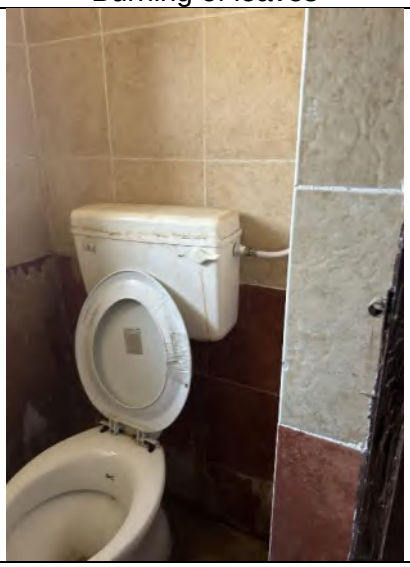
5. Not using organic detergent for laundry.
6. During visit grey water leakage was observed near the water filter area.
7. Absence of meter and sub-meter for measuring water consumption.

12. No waste quantification.
13. Improper segregation of kitchen waste.
14. Composting for biodegradable waste should be followed.
15. Dumping of waste in the water well and different parts of the property.

16. Absence of Renewable energy.
17. Absence of sub-meters for electricity.
18. Improper disposal of sanitary waste.
19. Excessive burning of leaves was observed around the property.

<table><tr><th colspan="2">Photo Gallery</th></tr><tr><td>Composting Pit</td><td>Burning of leaves</td></tr></table>

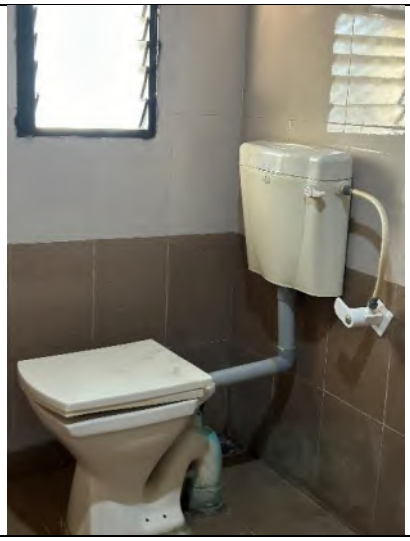
Salai Homestay

1. Absence layout plan in rooms and common areas.
2. Absence of sub-meters for electricity and water.
3. Stagnant water in the washing area, favouring unhygienic conditions.
4. Single flush system in washrooms.
5. No IEC for Waste Management.
6. Absence of waste quantification process.
7. Absence of recycling, upcycling of non-biodegradable waste including plastics, paper.
8. Absence of sub-meter for measuring electricity consumption.
9. Absence of emergency and evacuation plan.
10. Only 1 fire extinguisher in the property.
11. Usage of inorganic toiletries and detergent
12. Lack of IEC material.
13. Chemicals should be stored away from edible products
14. Lack of knowledge about SDGs, carbon footprint calculations and emissions. Lack of initiatives for their reduction.
15. Absence of Medical Kit.
16. Absence of souvenir shop

Colour coded dustbins	Unhygienic conditions in the utensil washing area

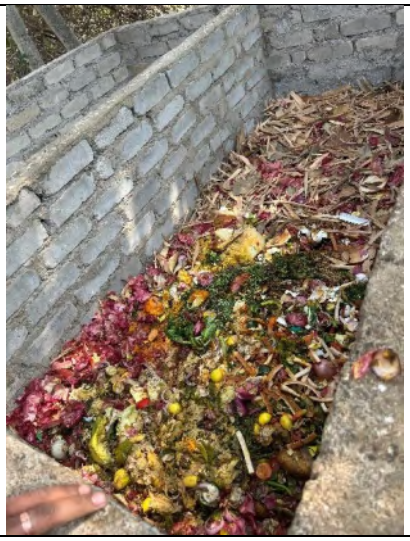
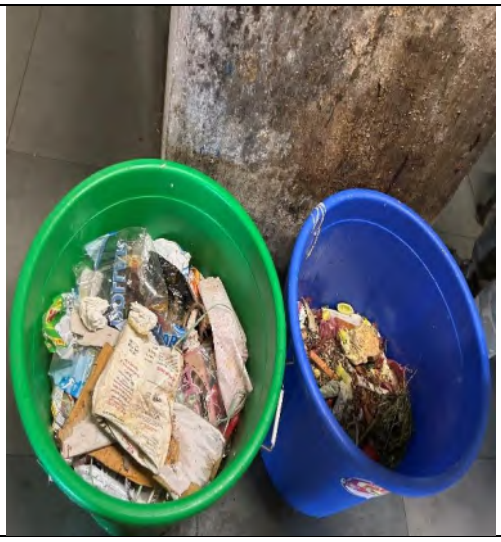
Serai Hospitality Pvt. Ltd.

4. The water dumped from the kitchen area should be through a covered drain, open draining leads to unhygienic conditions.
5. Presence of Cigarette buds in accommodation.

6. Electricity boxes should be closed in the entire property.
7. Burning of leaves should not take place.
8. Broken C&D waste should be removed from the property

12. Absence of grease trap and STP.
13. No IEC for Waste Management.
14. Absence of emergency and evacuation plan.
15. Absence of recycling, upcycling of non-biodegradable waste including plastics, paper

Composting Pit	Burning of leaves

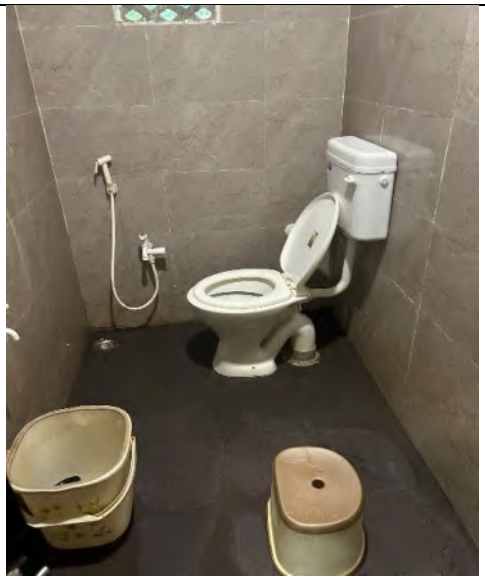
Tadoba Tiger Valley Resort

1. Absence of Layout Plan in Visitor rooms
2. Burning of mixed waste
3. Absence of colour coded bins for waste
4. Absence of recycling, upcycling of non-biodegradable waste including plastics, paper

Single Flush	Burning of Waste

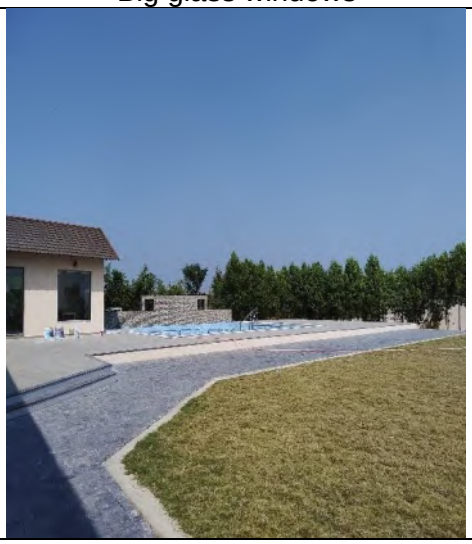
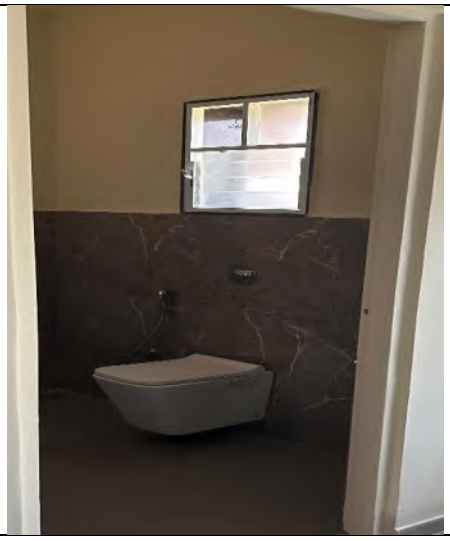
Tadoba Van Vilas

1. Absence layout plan in rooms and common areas.
2. Absence of sub-meters for electricity.
3. Improper disposal of sanitary waste.
4. Absence of colour coded dustbins in rooms as well as in the property.

8. Absence of recycling, upcycling of non-biodegradable waste including plastics, paper.
9. Presence of C&D Waste throughout the premises.
10. Laundry water being dumped directly into the field,

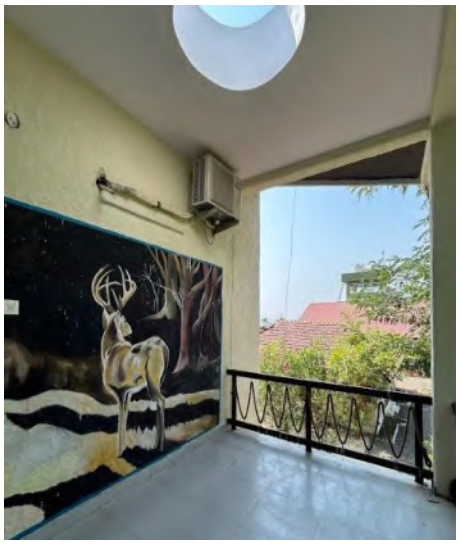
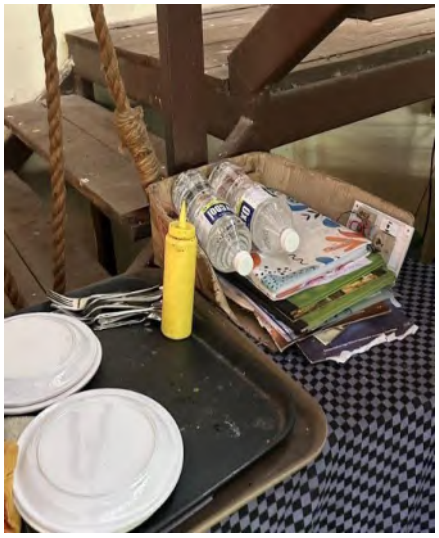
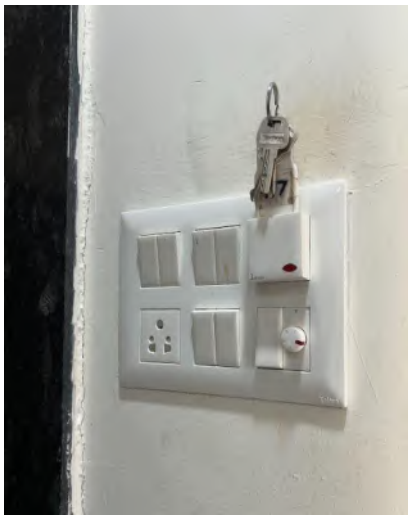
The Pugmark Jungle Lodge

1. No documentation has been shared
2. Few expired medicines in medical/ first aid kit
3. Burning of waste within premises
4. Absence of feedback mechanism for visitors
5. No layout of accommodation in rooms and common areas
6. Missing signages across the accommodation
7. Inadequate number of fire extinguishers
8. Absence of aerated water taps
9. Absence of sub-meters for electricity and water
10. Absence of renewable energy sources
11. No waste quantification process
12. Lack of information on waste and water conservation to visitors during check-in
13. Lack of knowledge about SDGs, carbon footprint calculations and emissions. Lack of initiatives for their reduction
14. No souvenir shop
15. Lack of carbon footprint calculations
16. No IEC for waste management

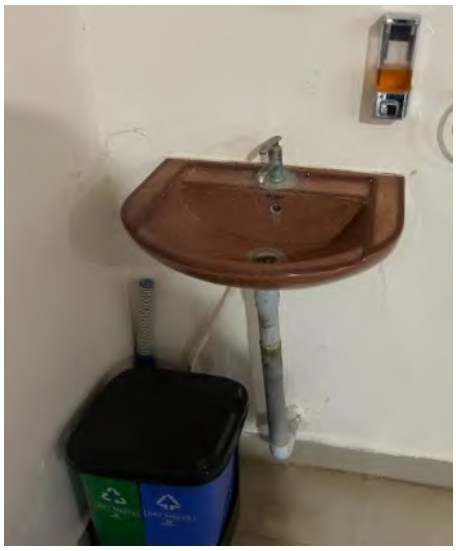
1. Absence of universal design like provision of wheelchair
2. No layout plan in rooms and dorm
3. No signages in the premises
4. No STP and grease trap
5. No initiatives for water management
6. Untreated laundry water flow to groundwater
7. No sub-metering for water and electricity consumption
8. Burning of sanitary waste across the road
9. Rusting C&D waste in the premises attracting mosquitoes
10. No plan for emergencies and evacuation
11. Not celebrating environment and water day etc.
12. Absence of souvenir shop
13. Absence of recycling, upcycling of non-biodegradable waste including plastics, paper
14. Lack of information about authorised waste dealers
15. Absence of fire extinguisher across premises and near LPG cyclinders
16. Usage of inorganic toiletries and detergent
17. Lack of IEC material

Burning of waste within premises

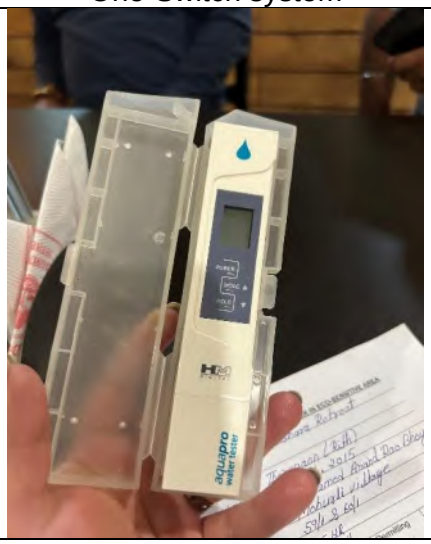
Vasundhara Retreat

9. Absence of meter and sub-meter for measuring water consumption
10. Absence of waste quantification process.
11. Dry Waste dumped near staff quarters.
12. Absence of recycling, upcycling of non-biodegradable waste including plastics, paper.

13. Burning of leaves.
14. Absence of sub-meter for measuring electricity consumption.
15. Uncovered Electric Wire Box and absence of fire extinguisher near it.

One-Switch system	Burning of leaves

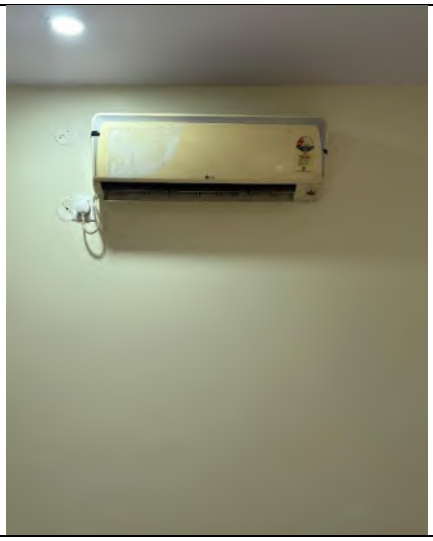
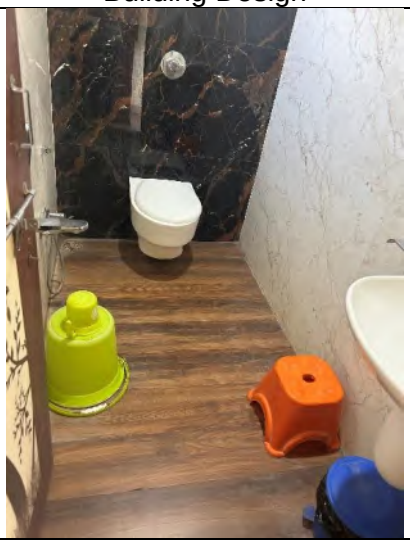
Waghai Home Stay and Restaurant

1. Layout plan is absent in all rooms
2. Absence of adequate signages across the property
3. Absence of Dual flush in washroom
4. Absence of aerated water taps
5. Absence of recycling, upcycling of non-biodegradable waste including plastics, paper
6. Lack of knowledge about SDGs, carbon footprint calculations and emissions. Lack of initiatives for their reduction
7. Absence of Fire Extinguishers at adequate places
8. No IEC material for visitors to highlight waste, water and energy management.
9. Absence of souvenir shop
10. Absence of Kitchen Garden

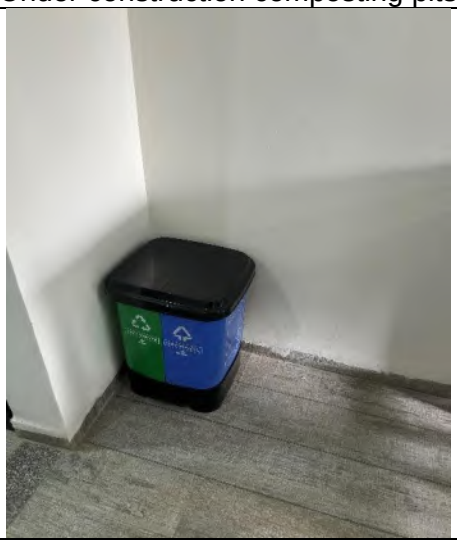
Waghranya

1. Layout plan is absent in all rooms.
2. Absence of Dual Flush System in rooms.
3. Absence of aerated taps.
4. Absence of meters and sub-meters for measuring water consumption.
5. Absence of STP and grease trap.
6. Burning of leaves
7. Absence of recycling, upcycling of non-biodegradable waste including plastics, paper.
8. Absence of Renewable energy in the accommodation.
9. Absence of one-switch system.
10. Absence of sub-meters for measuring energy Consumption.
11. Absence of signages in the property
12. Lack of knowledge about SDGs, carbon footprint calculations and emissions. Lack of initiatives for their reduction.

<table><tr><th colspan="2">Photo Gallery</th></tr><tr><td>Colour coded bins in visitor rooms</td><td>Burning of leaves</td></tr></table>

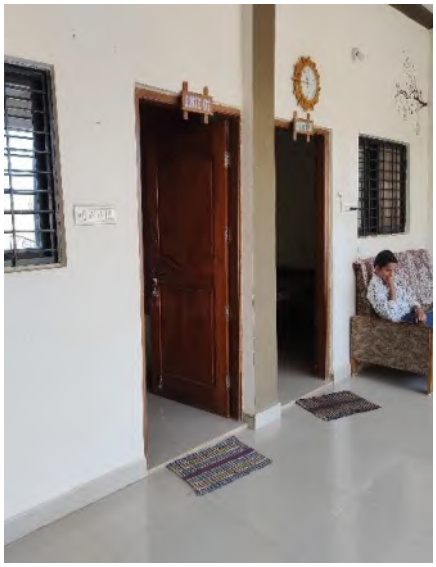
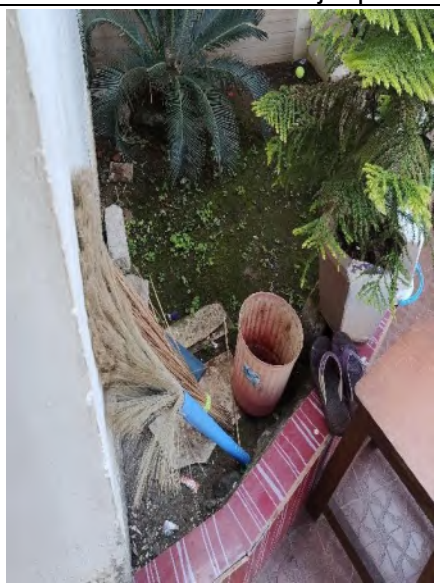
Wild Home Stay

1. Burning of leaves in common area of nearby homestays
2. Absence of fire extinguishers
3. No layout of accommodation in rooms and common areas
4. Absence of dual flush system in rooms
5. Absence of aerated water taps in rooms
6. Lack of colour coded bins for waste segregation
7. No waste quantification process
8. Lack of provision for composting
9. Lack of knowledge about SDGs, carbon footprint calculations and emissions. Lack of initiatives for their reduction
10. Use of inorganic toiletries
11. No souvenir shop
12. C&D waste kept in the premises
13. Absence of sub-meters for electricity and water
14. Lack of carbon footprint calculations
15. No IEC for waste management
16. Lack of participation among community

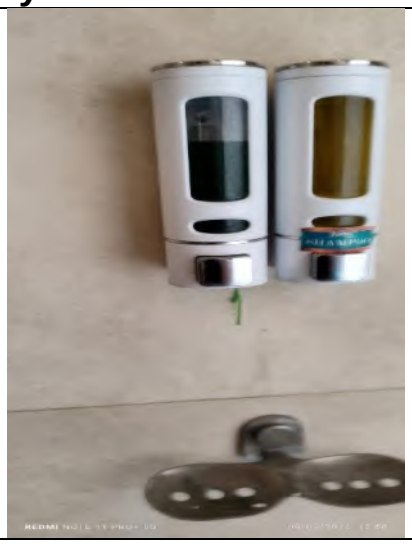
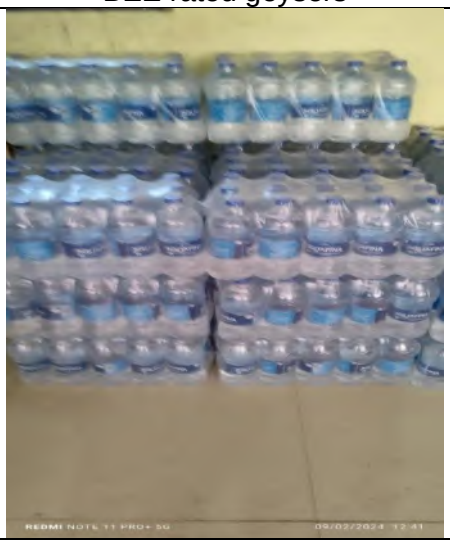
Jharna Resort

1. Mostly 2 storeyed structure.
2. No proper SWM plan in place.
3. The bins outside on the path ways serve as the secondary storage areas for the waste.
4. No carbon footprint calculation undertaken.
5. No processing of bio-degradable waste within their premises.
6. No colour coded bins for segregation of waste.
7. Rain dance arrangements at the property, which could possibly lead to disturbance for the wildlife.
8. Little knowledge about the SDGS, Carbon Footprints etc.
9. No concept of sanitary waste, C & D waste E-waste management.
